# BUILDER'S CONSTRUCTION VIOLATION REPORT

PROJECT NAME: REUNION RANCH

**STORMWATER POND INSPECTION  
SAND FILTER SYSTEM**

DISTRICT:	REUNION RANCH
DATE:	07.23.2020
WO :	2285003
TECH:	TAMMY YBARRA

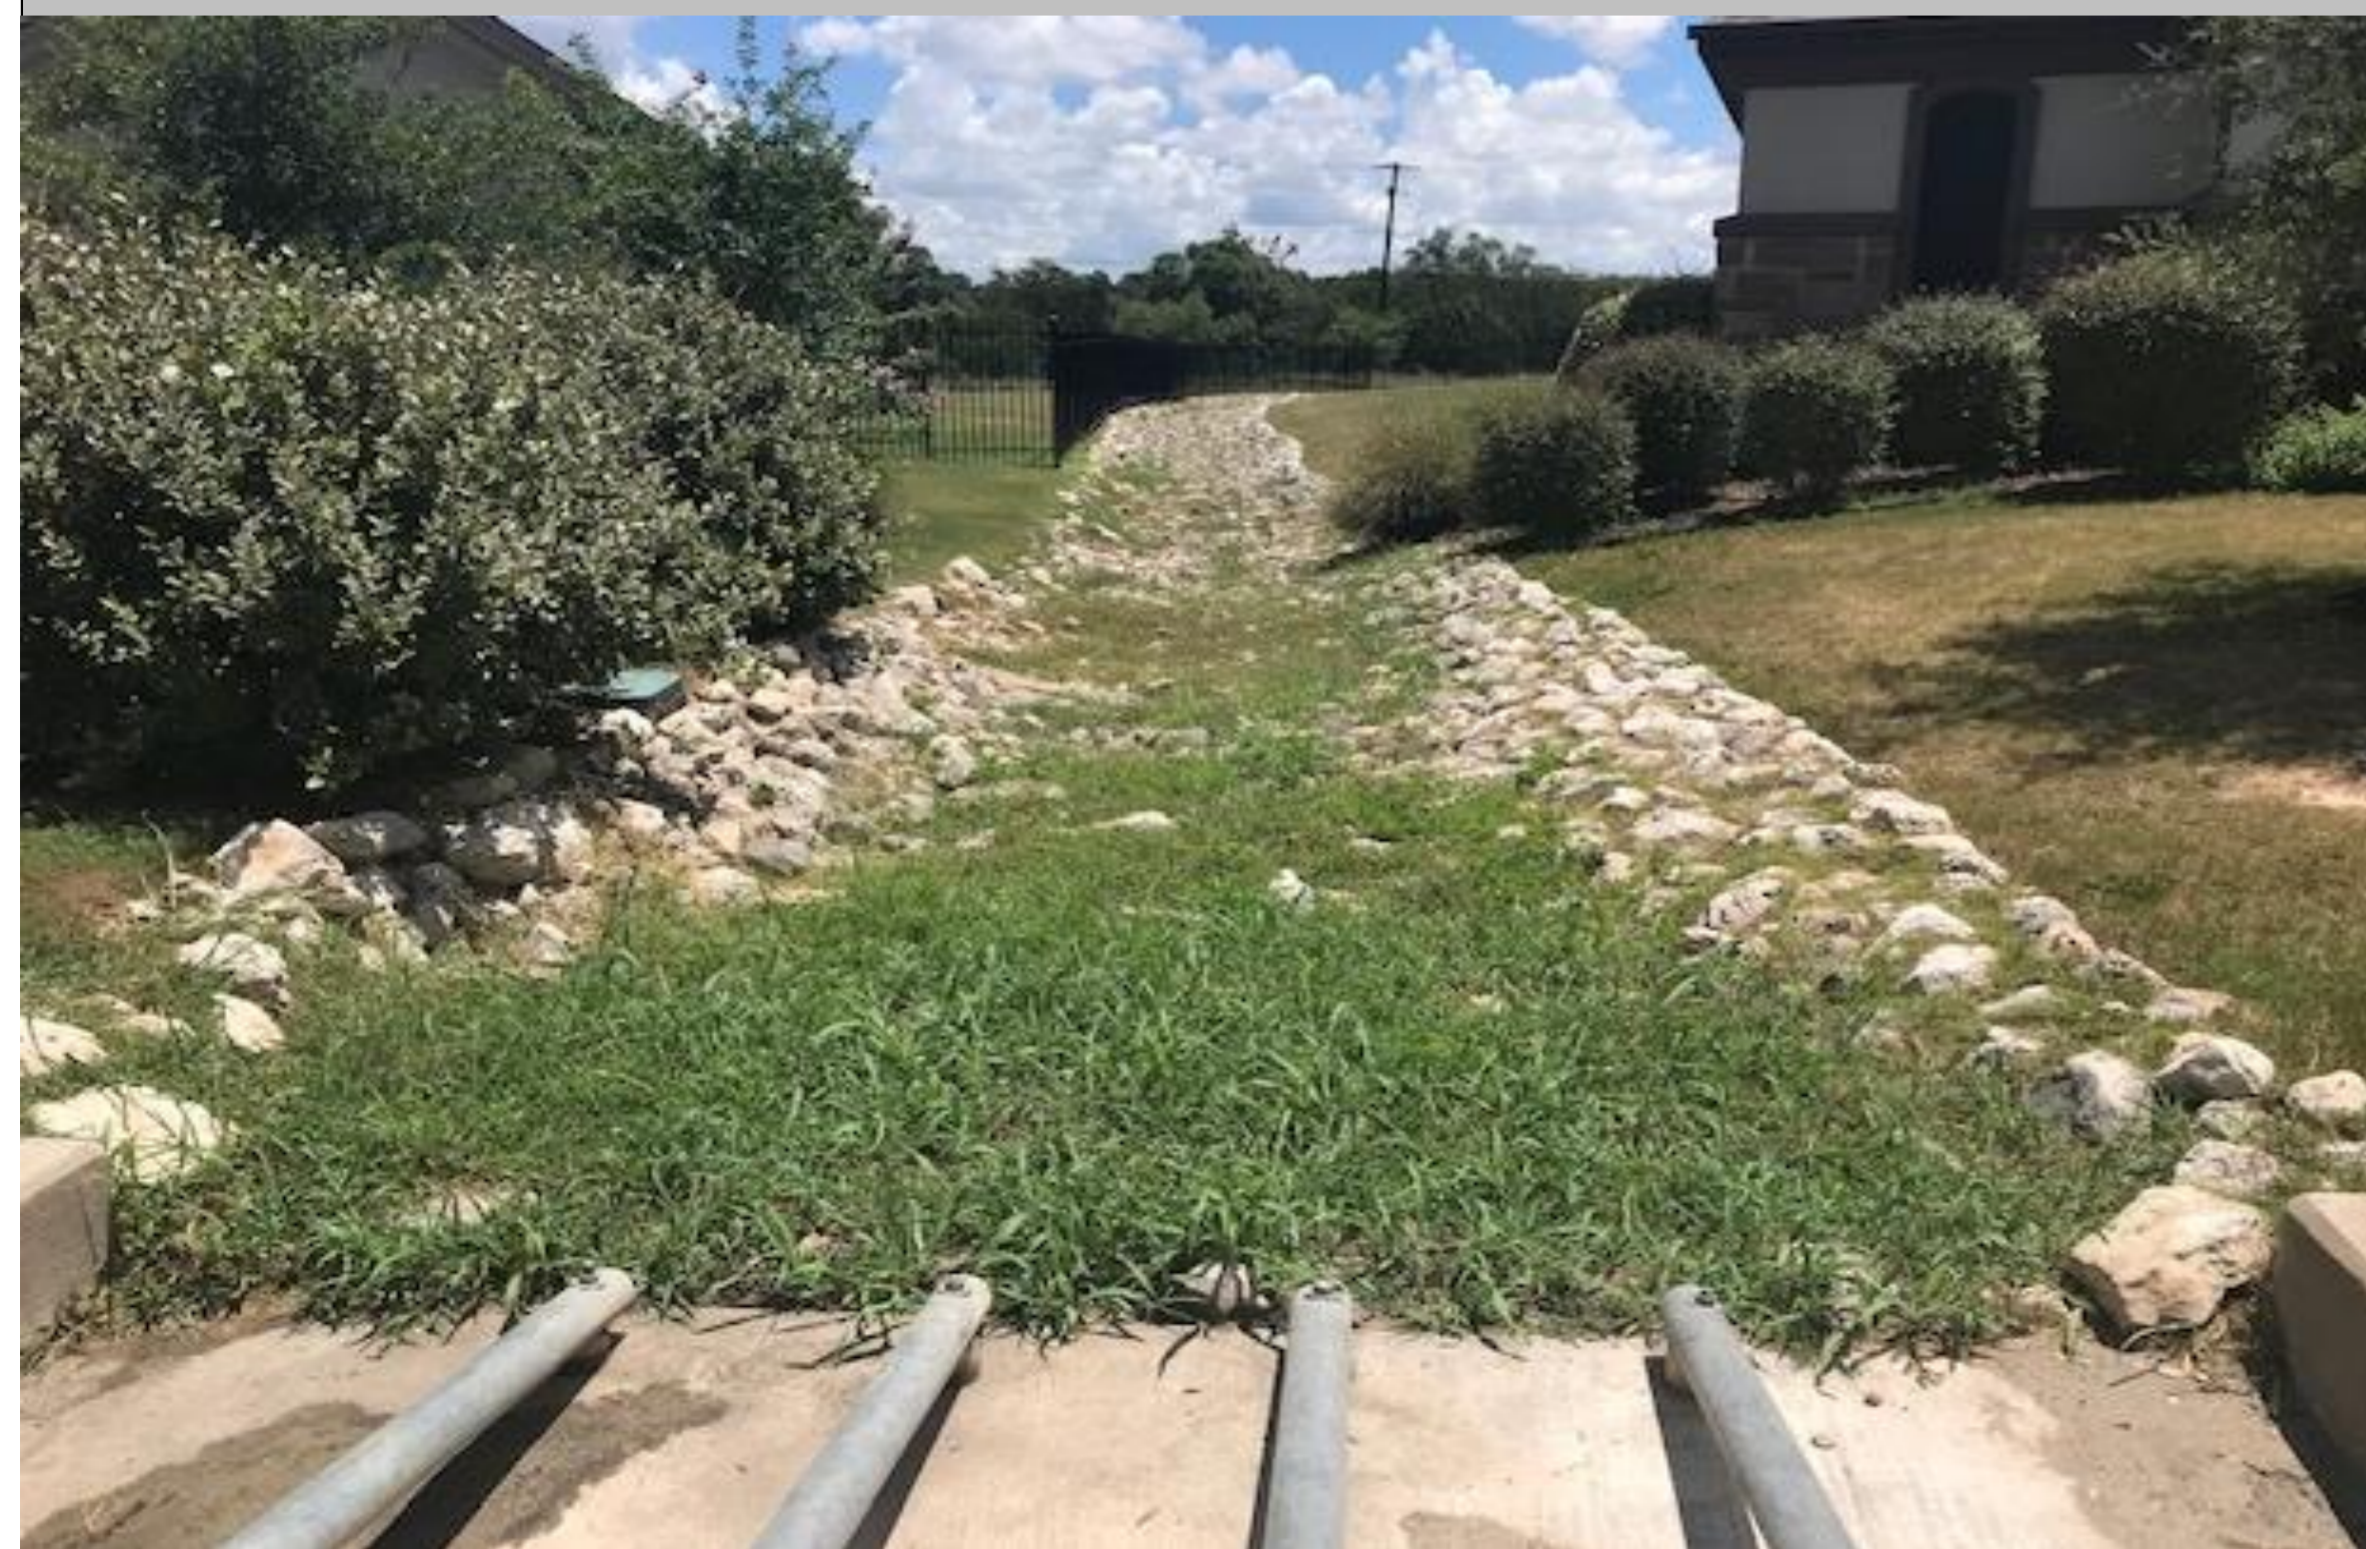
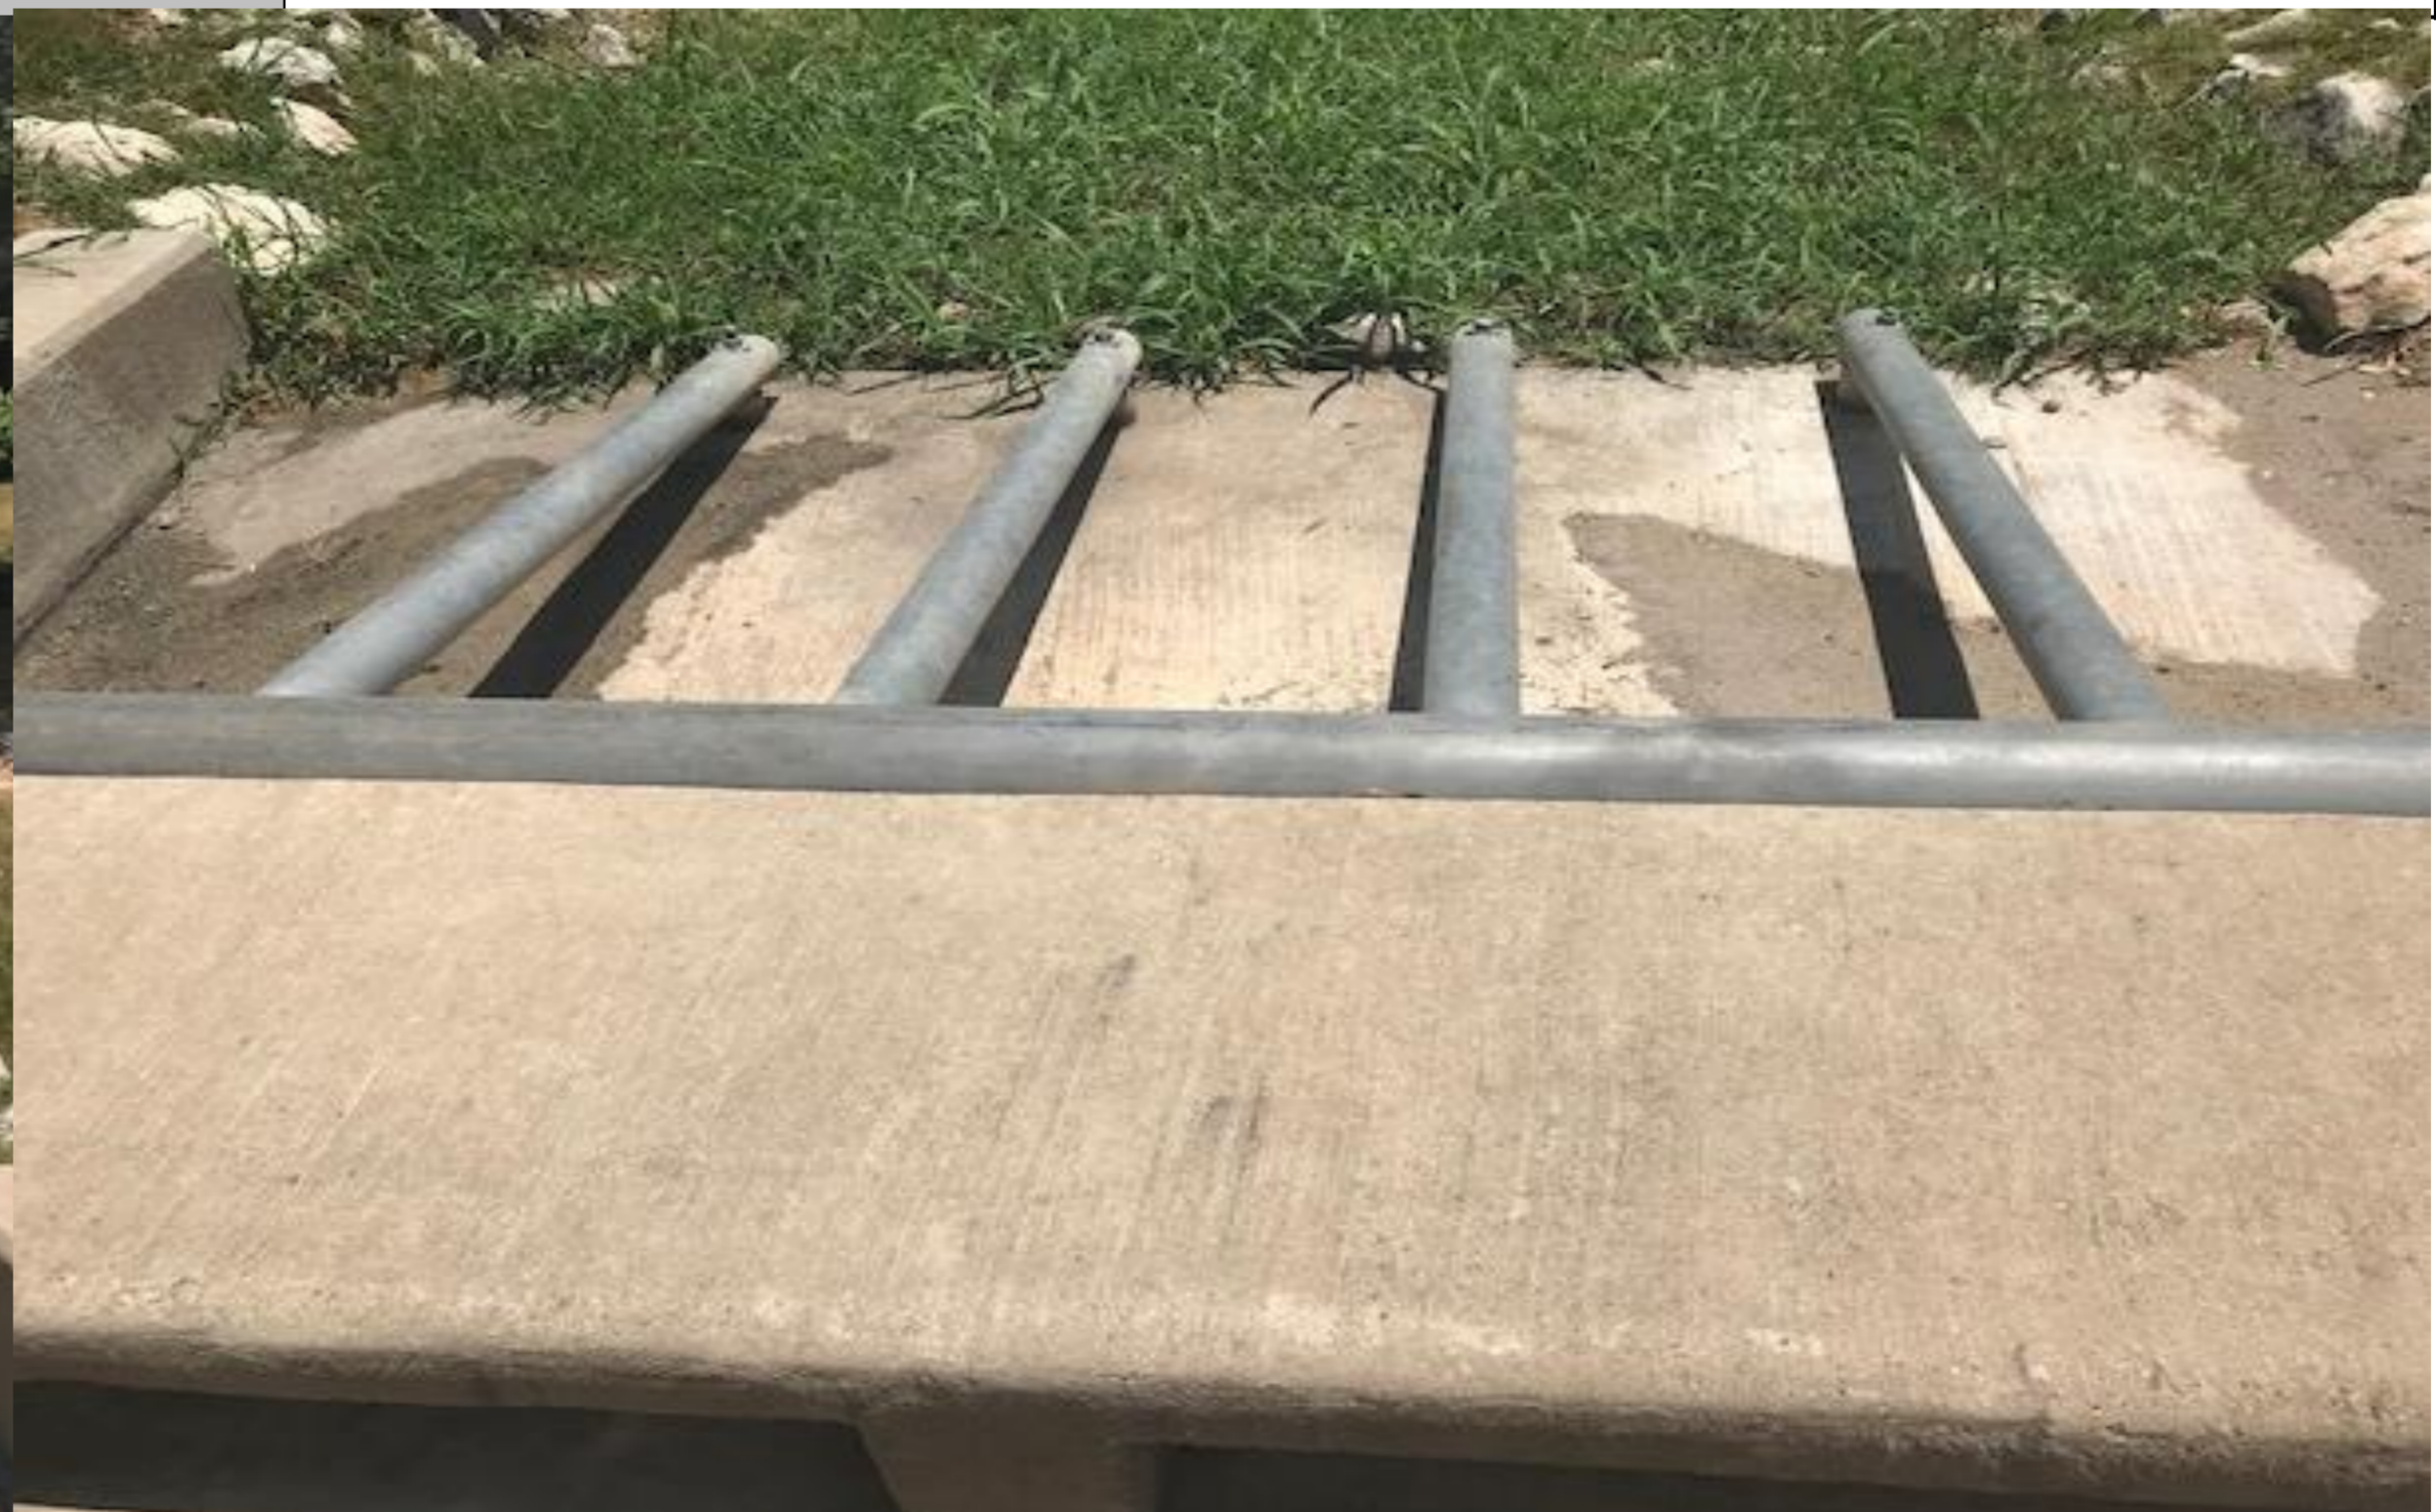
**LANSCAPERS NEED TO REMOVE GRASS FROM BULLROCK**

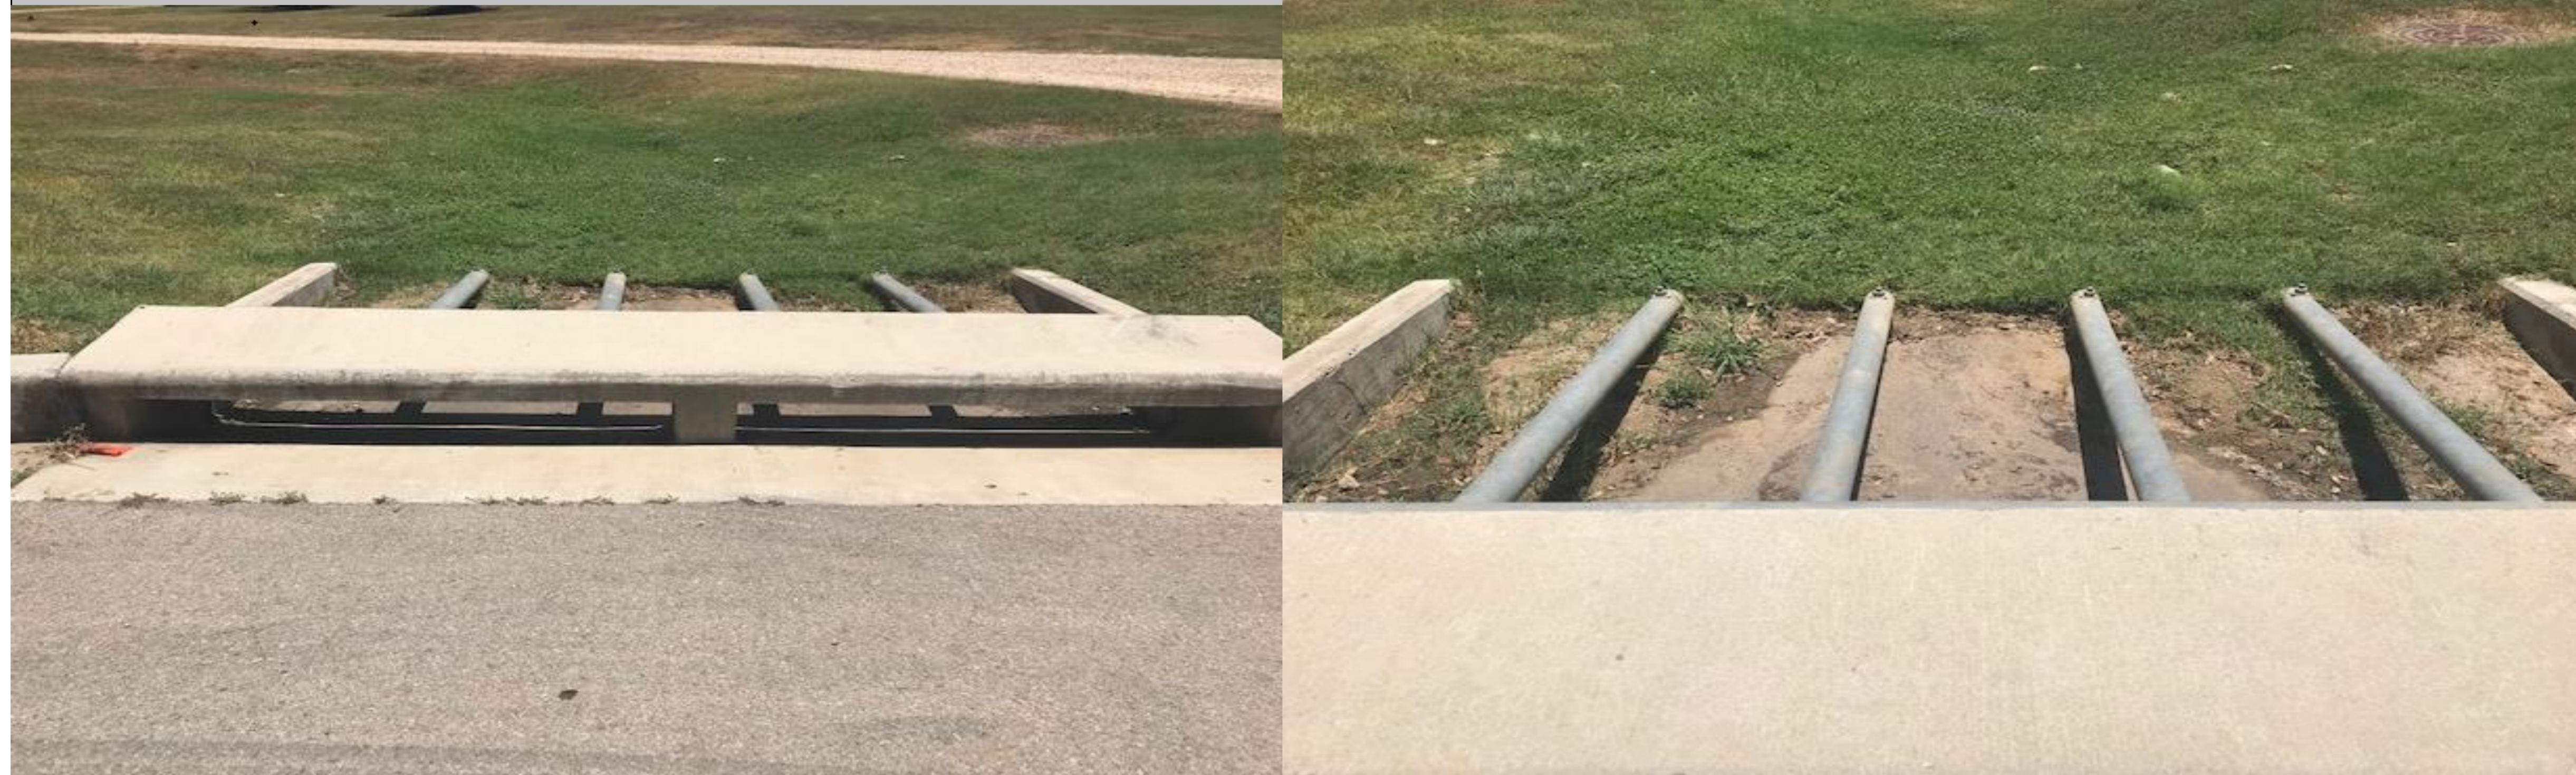
**INLET HAS SMALL AMOUNT OF SILT**

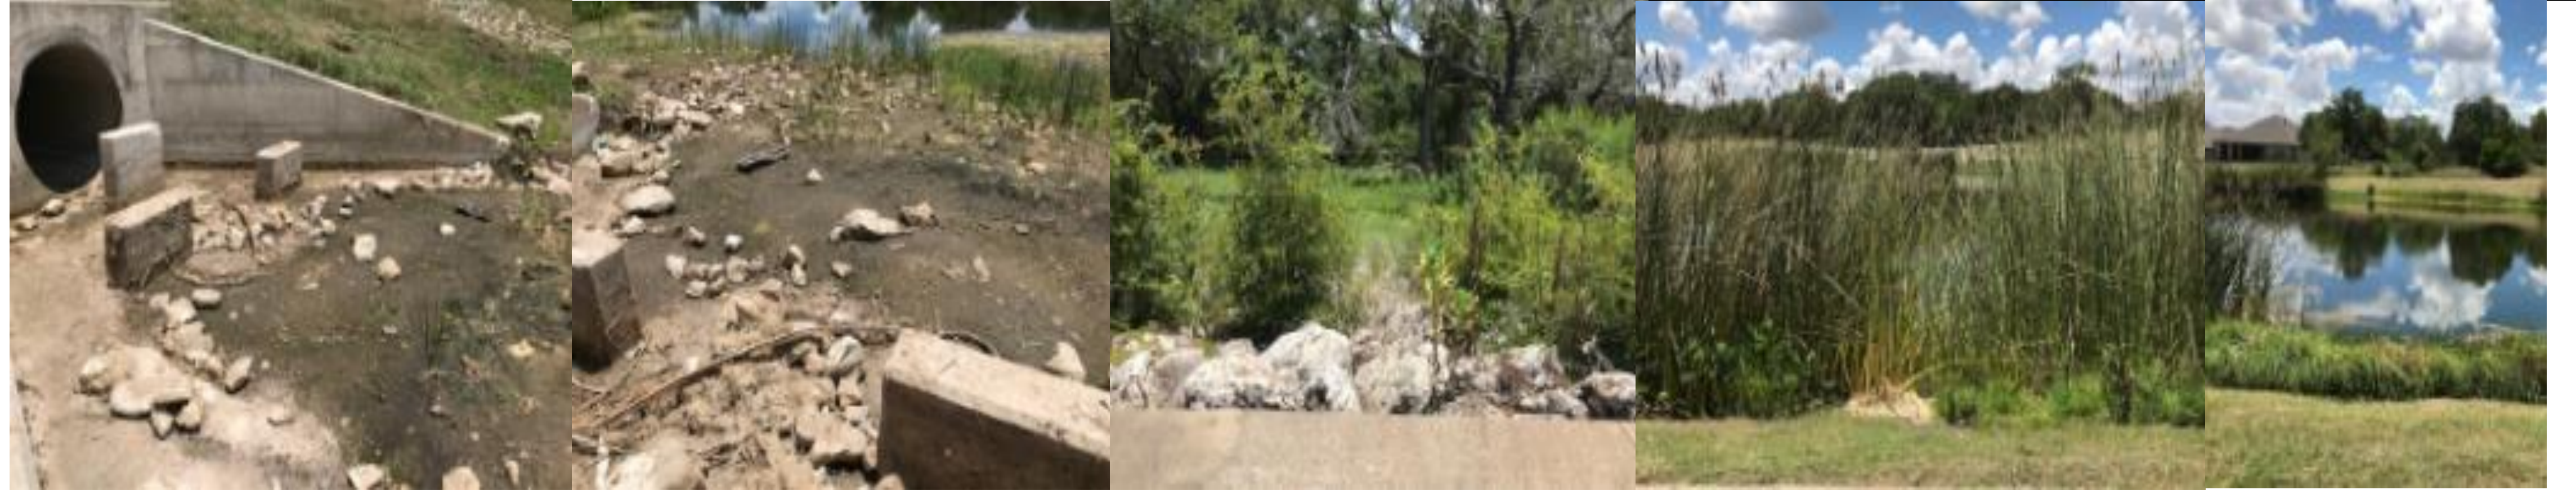
INLETS HAVE SILT & ROCKS - HIGH WEEKS AND GRASS AT OVE  
SOME AQUATIC LIFE IS OVERGROWN.

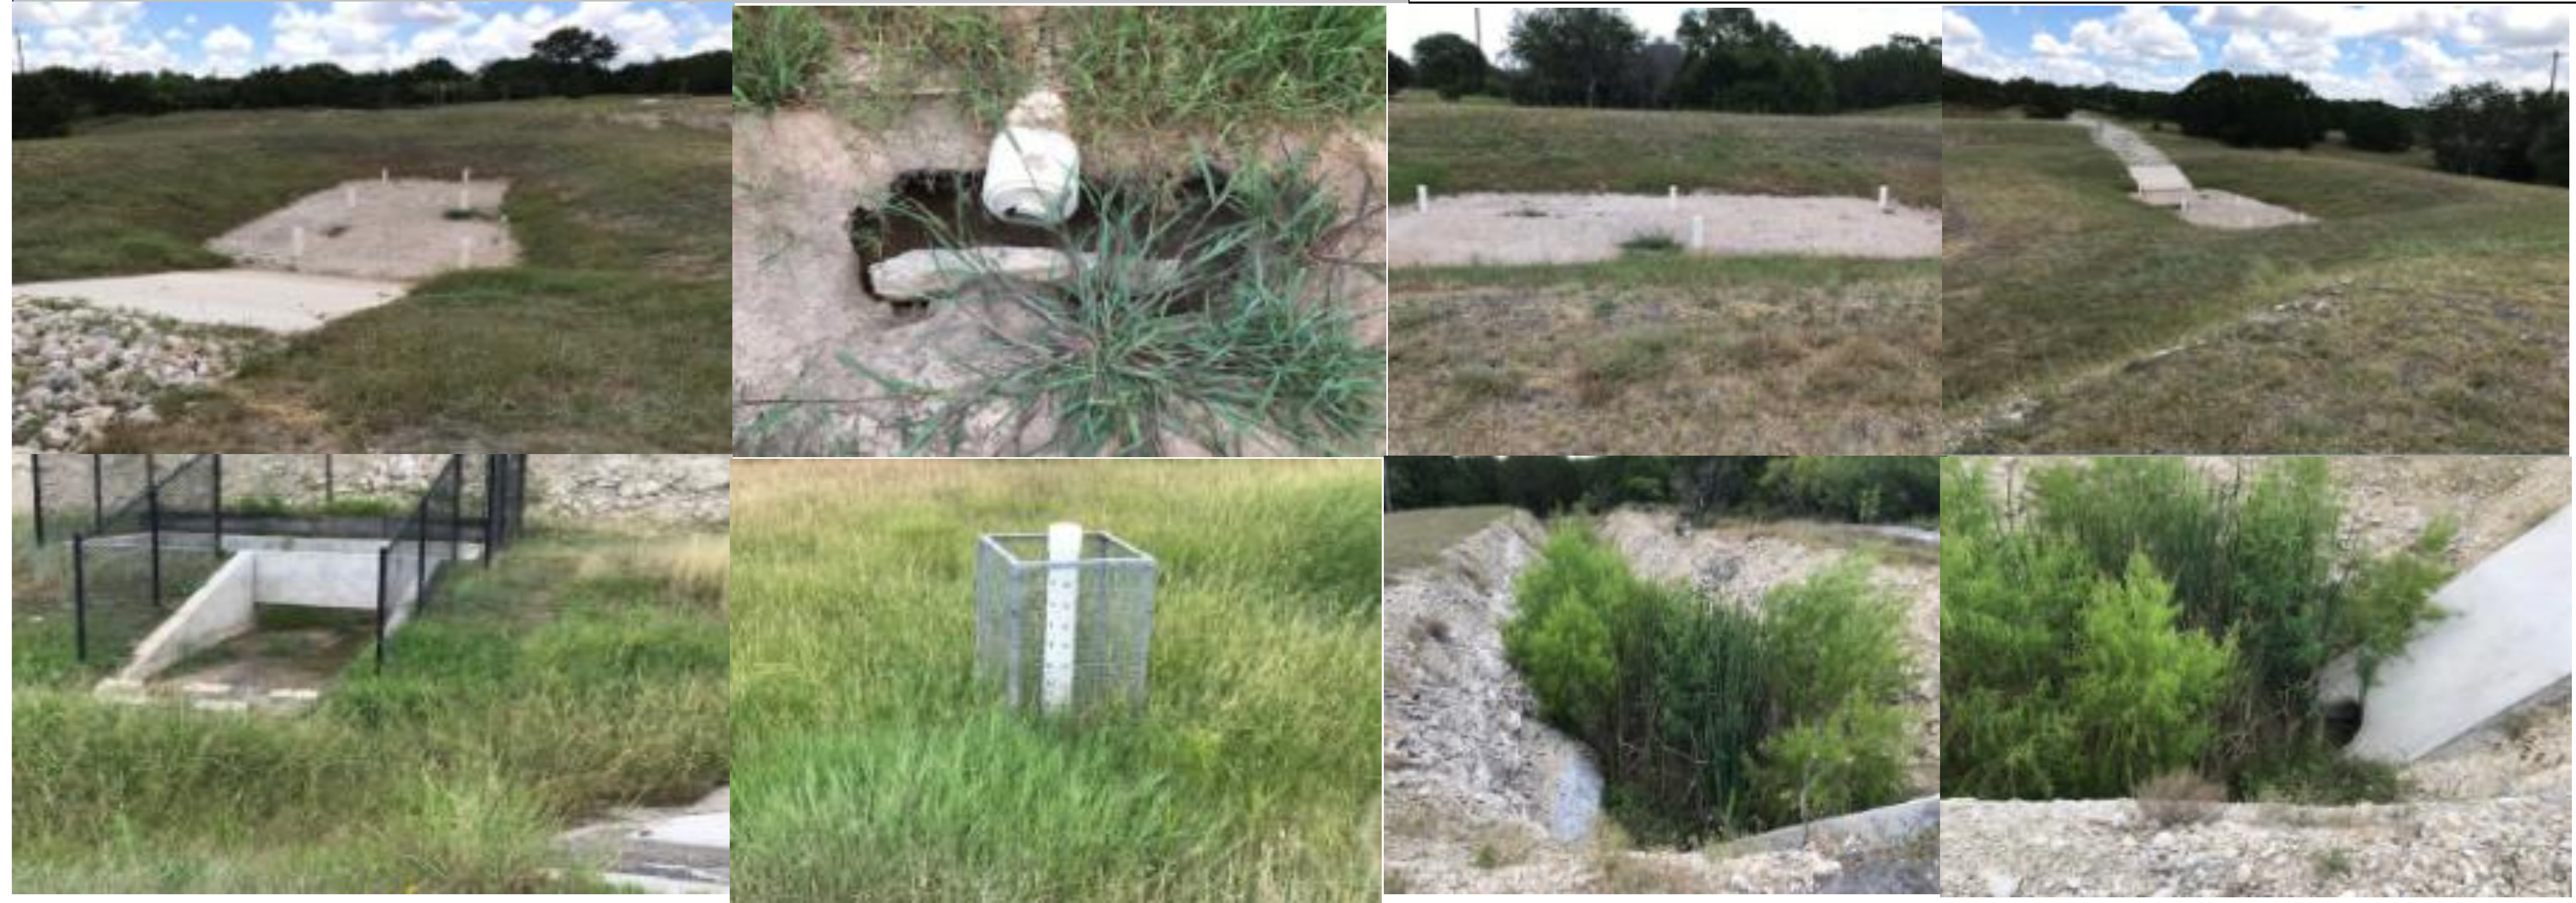
<b>Pond Location</b>	WQP 2-4 (END OF KATIE DR)
<b>Pond water level</b>	DRY
<b>Does the pond drain within 48 hours?</b>	N/A
<b>Sediment depth in the forbay?</b>	N/A
<b>Sediment depth in the sand filter area?</b>	N/A
<b>Trash found at site?</b>	NO
<b>Is vegetation below 18" in height?</b>	YES
<b>Trees or brush found in basin area?</b>	NO
<b>Condition of the media?</b>	SOME SILT - ONE BROKEN STACK
<b>Condition of vegetation around the out fall pipe</b>	N/A
<b>Was sediment found in the under drain piping? Remove open clean out tops and check</b>	N/A
<b>Any damage to structural elements (pipes, concrete drainage, retaining walls, gabian walls, etc.)?</b>	NO
<b>Discharge valve open operational</b>	N/A
<b>Emergency bypass valve closed and operational</b>	N/A
<b>Are all inlets in area clear of debris and sediment?</b>	NO - SILT IN INLET - LARGE BACK DITCH INLET FULL OF BRUSH - EQUIPMENT NEEDED

**COMMENTS** WO 2319072 - STACK WO 2319078 - INLETS

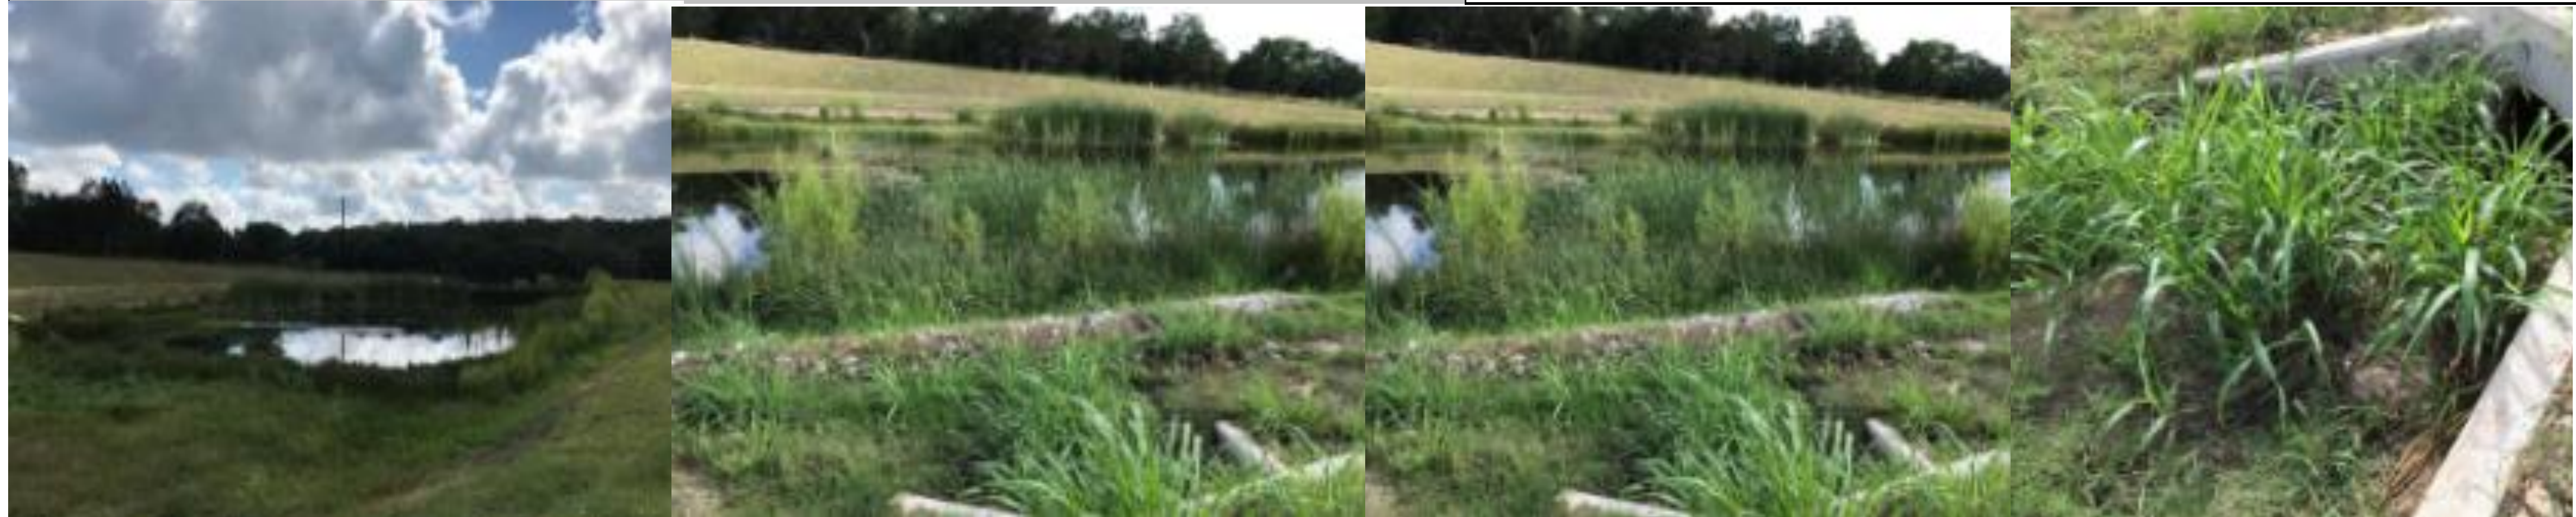
Pond Location	WQP 3-1 (BEHIND 3105 REUNION RANCH)
Pond water level	WET POND
Does the pond drain within 48 hours?	N/A
Sediment depth in the forbay?	N/A
Sediment depth in the sand filter area?	N/A
Trash found at site?	NO
Is vegetation below 18" in height?	YES - SOME AQUATIC LIFE IS TALL
Trees or brush found in basin area?	NO
Condition of the media?	N/A
Condition of vegetation around the out fall pipe	N/A
Was sediment found in the under drain piping? Remove open clean out tops and check	N/A
Any damage to structural elements (pipes, concrete drainage, retaining walls, gabian walls, etc.)?	NO
Discharge valve open operational	N/A
Emergency bypass valve closed and operational	N/A
Are all inlets in area clear of debris and sediment?	NO - OUTLET HAS VEGETATION
	<b>WO 2319098 - INLETS CLEANING</b>
COMMENTS
