**Reunion Ranch WCID
General Manager Reports for the month of
March 2021
Board Meeting: April 20th, 2021**

Subject: General Manager's Executive Summary Report

**STORMWATER POND INSPECTION
DRAIN OUTLET**

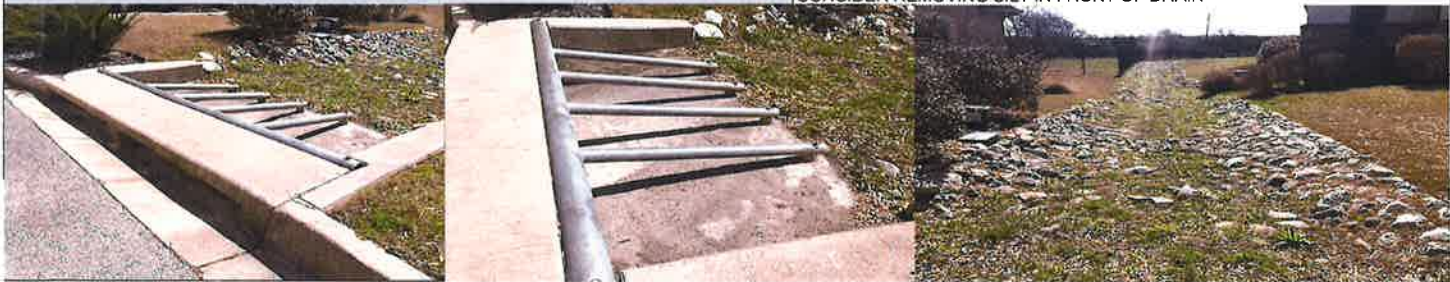
COMMENTS CONSIDER REMOVING SILT IN FRONT OF DRAIN

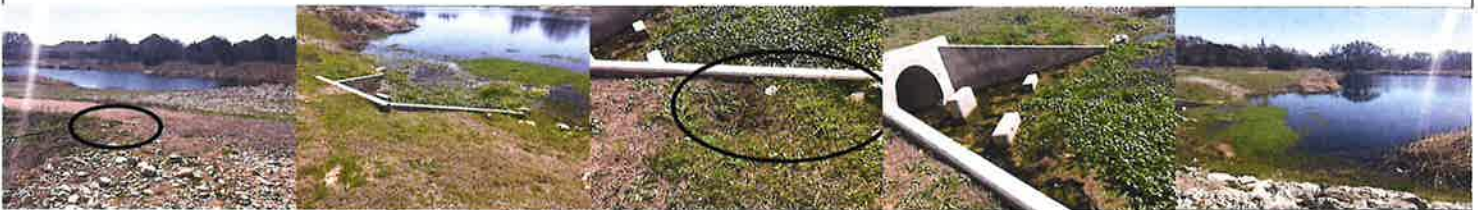
COMMENTS INLET HAS SEDIMENT AND VEGETATION - **WO 2396357**
EROSION ISSUE, SMALL HOLE FORMING - **WO 2461680**

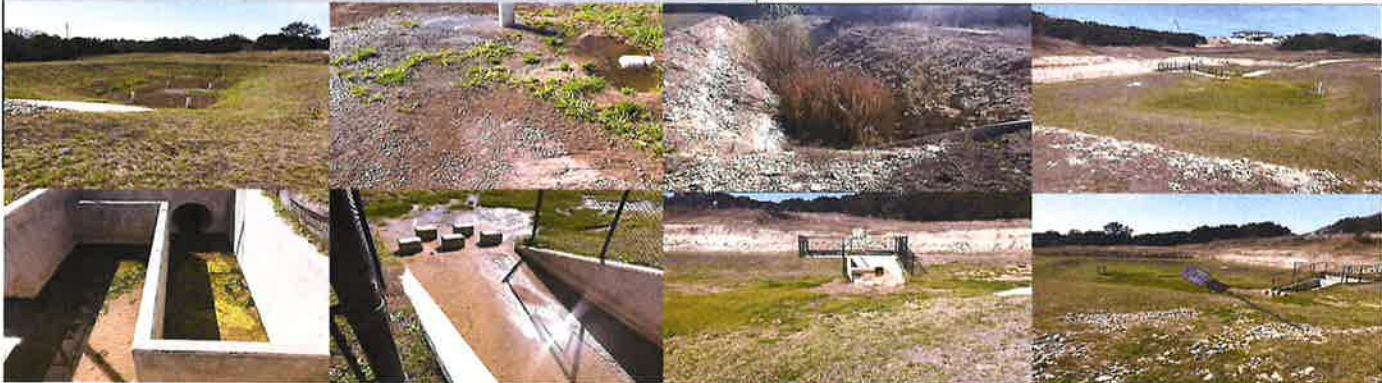
COMMENTS INVESTIGATE VEGETATION AT DEEP TRENCH - WO 2275994

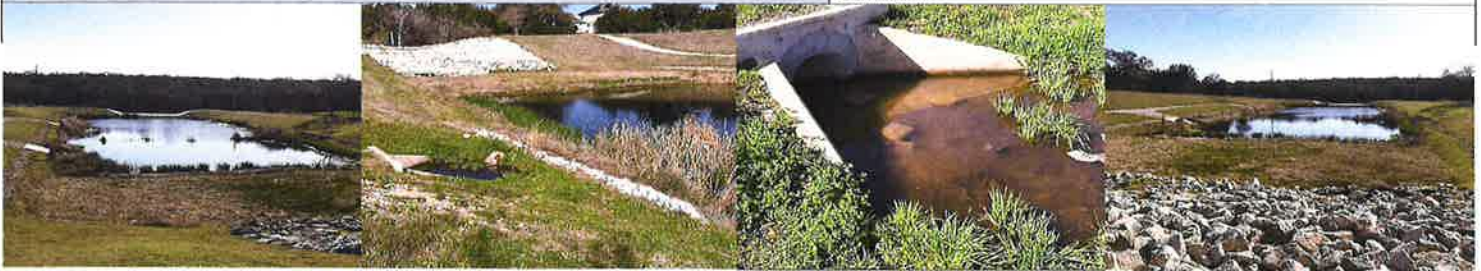
Pond Location	WQP 3-1
Pond water level?	WET POND
Inlets in good structural condition?	YES
Inlets clear of accumulated sediment or debris?	HAS SEDIMENT
Trash found at site?	NO
Sinkhole, cracks or seeps visible in the embankment?	NO
Erosion present at shoreline?	NO
Erosion occuing around the inlets or outlet structures?	NO
Discharge valve open operational?	N/A
Condition of vegetation around the out fall pipe?	GOOD
Excessive algae blooms present?	NO
Invasive plants present?	NO
Trees or woody vegetation present on the dam or embankment?	NO
Sediment has accumulated and reduced the volume of the pond?	NO DATA
COMMENTS	SEDMIENT IN INLET CAUSING WATER TO HOLD - WO 2396347

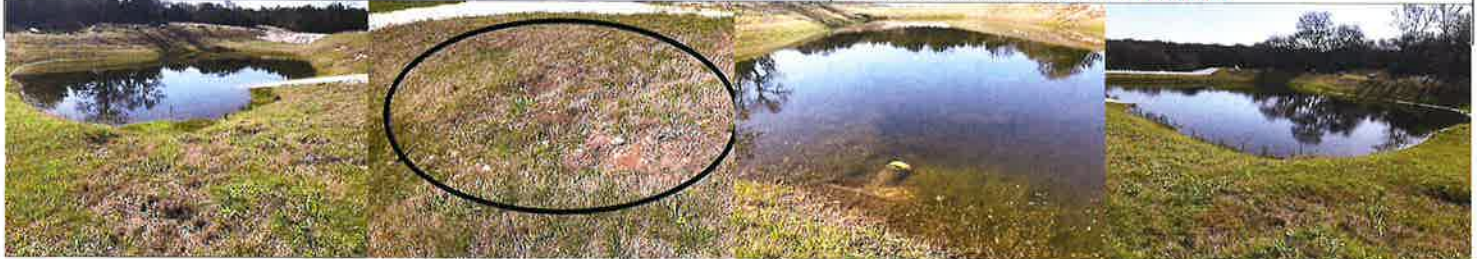
COMMENTS **EROSION ON EMBANKMENT WO 2461783**
